Serious Accident in the Hungarian Medium Voltage Grid During Live Working

The work accident took place on September 26, 2018, on the outskirts of Pányok in the northeastern part of Hungary.

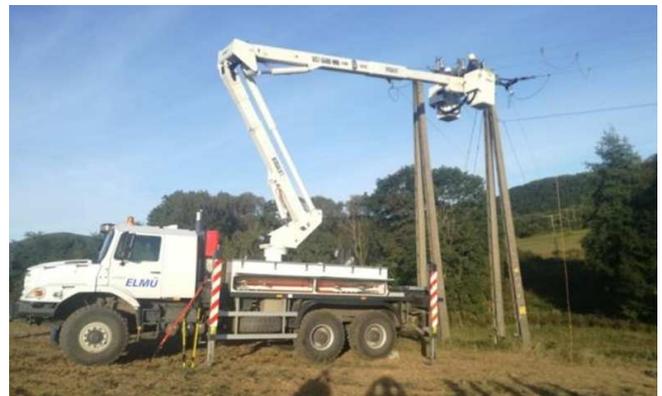
The task was to dismantle and get down the previously substituted pole-mounted switch using the combined live working method. The team consisted of three people, and all three were MV-2 certificated workers fulfilling the job requirement. An insulated bucket truck (Versalift VST-5500-MHI, 46 kV) shown in Fig. 1. and associated live working equipment were used to perform the task. The necessary tools, insulating blankets, and personal protective equipment were available; they had the essential qualification. The weather was good for LW, with temperatures of 15-16 °C, sunny weather, and moderate winds at the time of the accident. On the grid part, a limited operational state was applied (LOS), the power line was prepared and suitable for LW. That task was the second and last one for the working group that day [6][7].

Fig. 1. The location of the accident with the pole and the bucket truck.

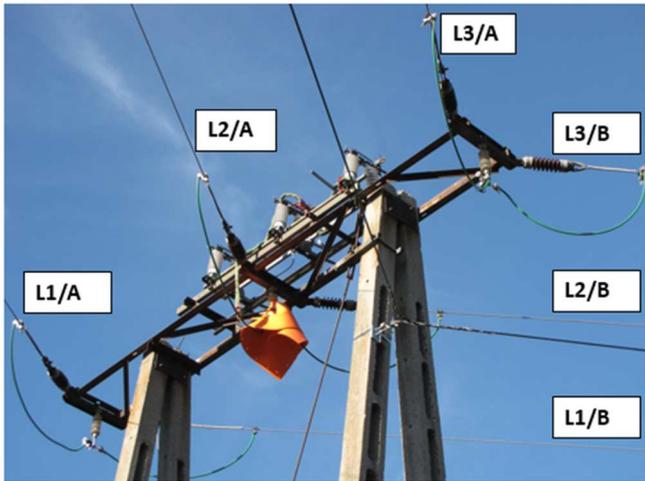
According to the plan, they started the work on the “A” side of the portal pole. The phase conditions of the pole-mounted switch are in Fig. 2. First, they loosened the pole-mounted switch fixing bolts and placed the “A” side four-branch hoisting rope branches between the L2-L3 and then L1-L2 phases from the bucket. The same operations would have been performed after navigating to the “B” side of the portal pole. It would then have been lifted off the pole-mounted switch with the auxiliary arm [6][7].

Fig. 2. The phase conditions of the pole-mounted switch are on the "A" and "B" sides.

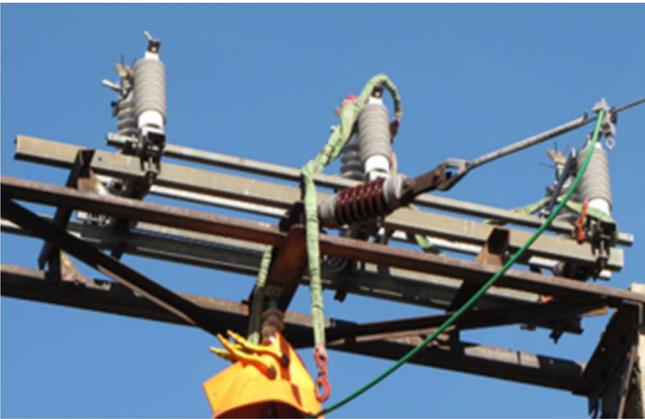
The work leader and the third personnel (worker #2) approached the pole-mounted switch in the bucket. A total of 3 electrical insulator blankets were used for the "A" side cover. One for the L1 phase conductor, one for the LW insulator of the L2 phase jumper (this was the only cover on the network after the accident), and one for the L2 phase conductor was placed. After placing the insulating blankets, the fixing screws of the pole-mounted switch were removed between the phases L2-L3 (on the "A" side). The two branches of the four-pronged hoisting rope were then passed over the insulators of the middle phase of the closed switch and the other two branches. It was then fixed for lifting from the L3 phase conductor on the "A" side of the pole-mounted switch (Fig. 3). The rope was also set on the "B" side despite the initial plan since the working position was judged to be sufficiently safe [6][7].

Fig. 3. The pole-mounted switch partially prepared for lifting.

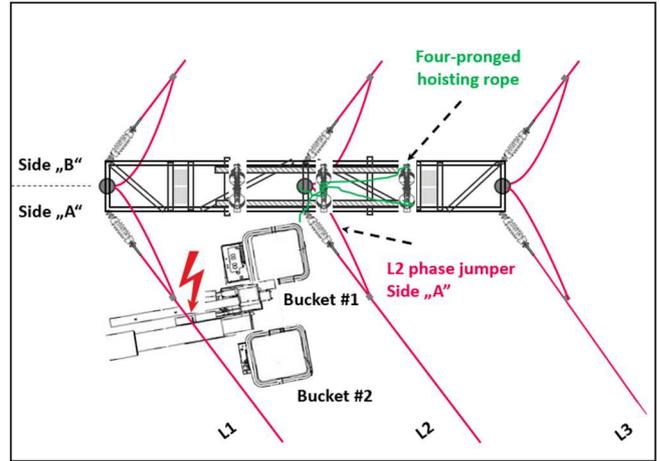
After that, ascending with the boom, the safety metal contact wire of the handling jib's stiff approached the L1 conductor within the MAD. Thus, the operating board in the bucket became energized (since all metal parts must be

connected at the boom). The work leader handled the operating board without insulating gloves, so he contacted the phase potential through his left hand. At the same time, his right hand (approaching the grounded structural parts within the MAD) brought a ground potential into the system as a second contact point resulting in an earth fault. Thus, he suffered severe electric shock and burns in the bucket. The schematic drawing of the accident is presented in Fig. 4.

Fig. 4. The top-view of the accident on a quasi-scale drawing.

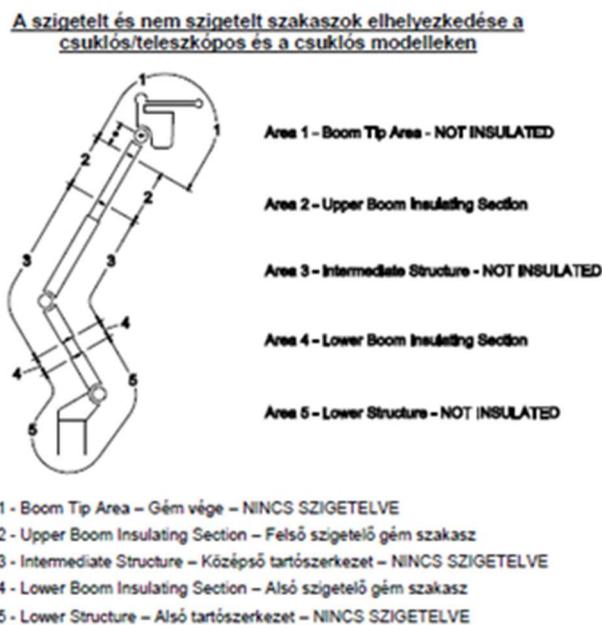
should be closer than 30 cm to the bare phase conductor. The required minimum approach safety distance could not be kept during the boom movement before the accident regarding the uncovered network components. All three members stated that they did not know that the metal parts around the bucket were in metallic contact and that the supplementary boom or the jib's metal part could conduct phase potential to the operating board. However, this information is also included in the truck's operation and maintenance manual, and there are warning pictograms placed on the truck, as presented in Fig. 5. [6][7].

Fig. 5. Warning pictogram on the boom truck.

Since the bucket truck was damaged in the accident during the fault current, the DSO also took safety measurements on the vehicle. So that, an extraordinary inspection of the insulated bucket was carried out from the electrical safety point of view. To avoid similar situations in the future, the DSO contacted the manufacturer to investigate whether the jib metal wire could be placed or covered in another way [6][7].

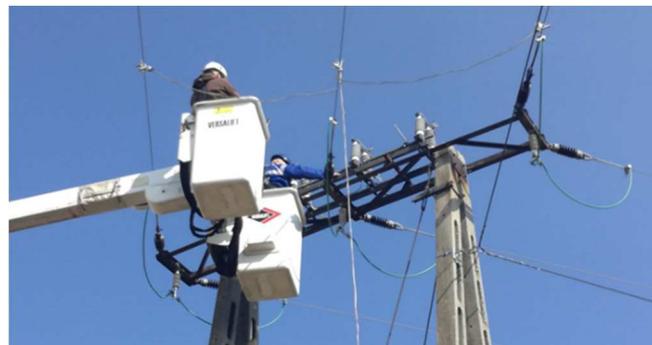
The subsequent omission can be attributed to the work leader who took worker #1 position due to a more even workload on the team members. Although he handed over the supervision tasks, he did not specify the exact location of worker #1, so worker #1 was in the vicinity of the left rear corner of the bucket truck. During the reconstruction of the accident (Fig. 6), it was established that from this position, looking almost vertically upwards from below the bucket, it was not possible to see how far the workers in the bucket and the upper boom were from the phase conductors. It was also impossible to estimate whether the required safety distances could be maintained. The location of the supervisor (worker #1) was not appropriate [6][7].

Fig. 6. Accident reconstruction on the pole.
