## **CIGRE 2023 Sendai Colloquium, Japan, 3-7 October 2023**

**5305279, B2, PS2**

### **Possibilities of Expanding Working Safety during Live-Line and Vicinity Working**

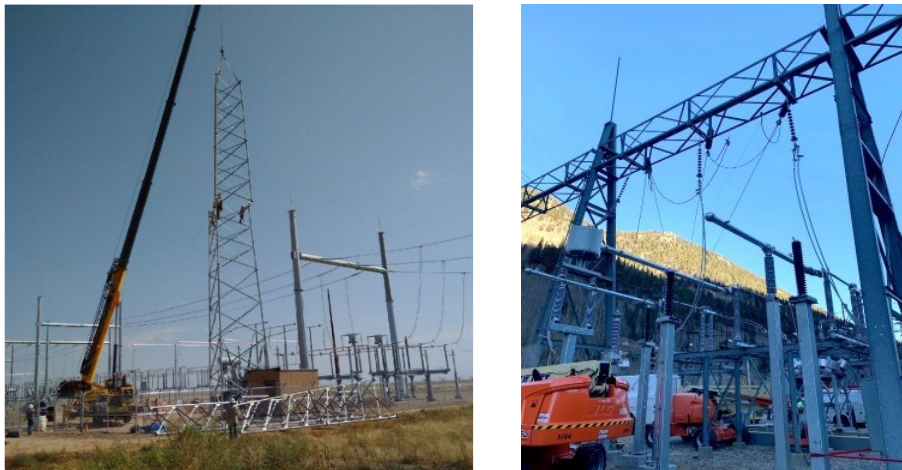
Figure 4. Location of AC induction related accidents: crew erecting a transmission lattice tower near a live 345 kV substation in NM, USA (left), crew replacing a 115 kV circuit breaker on a de-energized line that runs parallel with a 230 kV line CO, USA (right)

**Case 1** – In 2015 in a substation in Dora, NM, USA, a civil crew was erecting a new 195-foot (60 m) transmission lattice tower 75 feet (23 m) near an energized 345 kV substation yard and live lines (Figure 4 - left). After erecting the 60-foot (20 m) base of the tower, a crew of three climbed the structure and proceeded to aid and align the second lattice section suspended from a crane when they received electric shock due to induced current. The climbers had fall protection and experienced muscle related symptoms due to the shock and alerted the crane operator. They were able to climb down and received medical attention. The crane used a synthetic sling for holding the load. While touching the top lattice structure,

the workers became in series with the induced circuit of the two tower sections. As a result, the work practices were modified to add bonding jumpers between structures for this activity. Also, ac induction protective suits may be applied in addition to proper bonding jumpers.

**Case 2** – In 2021 in a substation in Colorado, USA, a substation crew was replacing a 115 kV circuit breaker (Figure 4 – right). The 115 kV line had TPG at the substation terminal, and the line ran parallel to an energized 230 kV line for several miles. During work, the TPG had to be repositioned to accommodate and position mechanical equipment. A worker on a 60-foot aerial platform loosened a TPG clamp with his hands with the intent to slide it through and reposition it, without a live line tool. OSHA requires workers to use live line tools [9]. The clamp lost contact with the conductor, and it detached. The worker sustained electric shock due to induced current and had hand-to-hand contact in series. The worker sustained injuries on the tip of the fingers of both hands, where the electric current entered and exited and had to go to the hospital for medical care. The worker had assumed that a visual disconnect from the live substation (circuit breaker and disconnects were open) was a sign of a visual “open” to the line and didn’t recognize the risk of induced current on the line through the TPG. The crew suffered from distraction and fatigue from getting the bay ready for another contractor. Typical training in the US covers AC induction hazards in overhead lines and not inside substations. Proper TPG removal with live line tools could prevent this incident. Conductive clothing was not used at the time but could have served as a backup protection and averted the injury. The utility is considering field trials for substation applications in the near future.

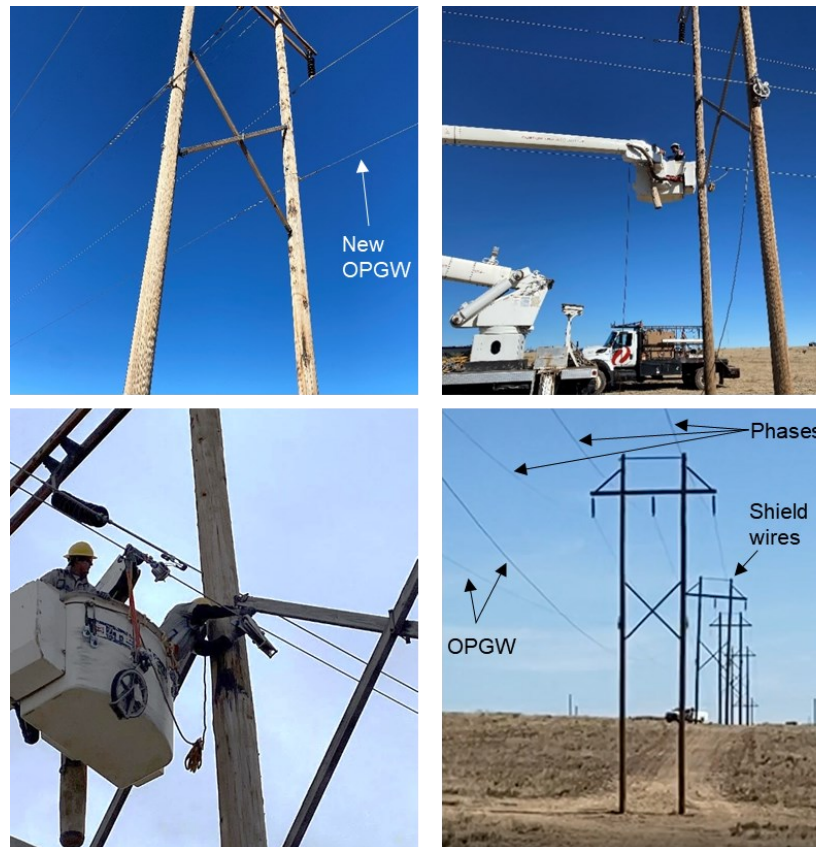
Figure 7. Field trial for use of conductive clothing for installing OPGW under an energized 115 kV line with wood H-frame

**Case 1** – An electric utility in USA installed a new set of two OPGW wires of 24 pairs of fibres each on an existing 115 kV, 41 miles (66 km) length line in Texas during February of 2022. The line has H-frame wood pole structures with two 5/16” galvanized steel shield wires at the top of the wood poles (Figure 7). It runs through flat terrain on cattle farms with little vegetation. The length of new OPGW conductor to be installed was 4 miles (6.4 km).

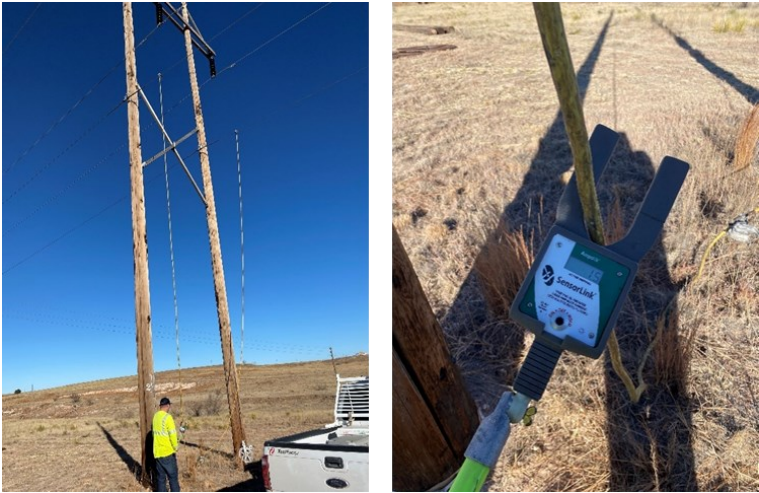
Figure 8. Measurement of AC induced current (1.5 A) with a live tool and a fork type ammeter on the TPG

During the work, the crews measured how much induced current was flowing through the OPGW wire (Figure 8). The crew used a fork type ammeter mounted on a hotstick on the TPG jumpers and measured 1.5 A. That was the result of a “loop” of approximately two miles between two master grounds, OPGW wire, and soil. The OPGW wire was positioned approximately 15 feet (4.6 m) under the live phase conductors. The OSHA limit for requiring controls for induced current and voltage is when the worker exposure exceeds 6 mA, according to regulation 29 CFR 1910.269(q)(2)(iv) [9]. The reading of 1.5 A exceeds the occupational limit by 200 times. Therefore, TPG and special conductive suits were used as controls for worker exposure.

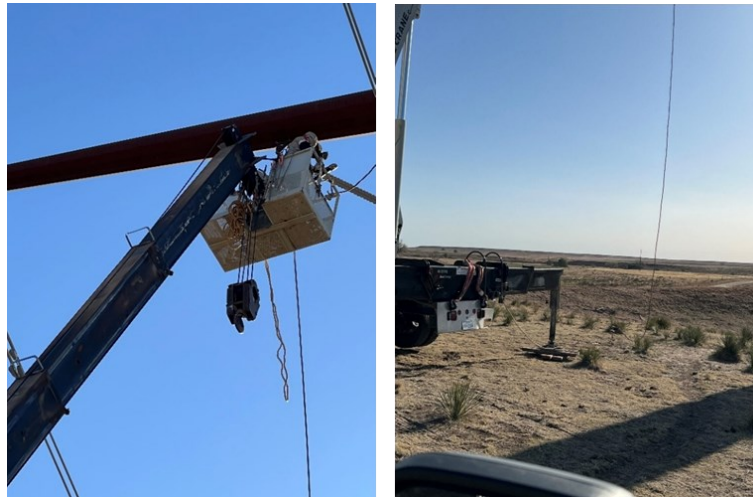
*Figure 9. Field trial 2: use of conductive clothing for repairing OPGW over a double circuit 345 kV line with single pole, weathered steel with one circuit deenergized (left); wildfire caused due to flashover of insulating aerial crane outrigger (right)*

The crews assumed that AC induction was present during the job and TPGs were applied, and special suits worn. The downed OPGW was inspected, and it didn't have broken strands, so it had to be raised and supported back into the tower where the hardware broke. The optical fibre was tested and had no damage and no alarms. The crews hung master grounds (TPG) on each structure, in a bracket ground configuration. The tower poles were 140 ft high, so the crews used two insulating cranes (ANSI/SAIA A92.2, Category A [15]) to reach out to the OPGW. The conductor was moved by using the aerial basket with its rolling type dolly. Prior to accessing the conductor, the crew in the aerial basket used live line tools for bonding the aerial lift to the OPGW and establish an EPZ. See Figure 9. The work was completed in one day.

During the job, the crews observed a little fire caused by a flash through one of insulating crane outriggers. The cause was induced voltage flashover. The sparking from the arc caused vegetation to ignite and the crews had to attend the fire and extinguish it with no further consequences. The flashover started right after the first set of TPG was installed on the OPGW. The crew had grounded the crane chassis to the ground conductor on the metallic pole. Then that ground connection was bonded through another TPG jumper to the phase conductors and OPGW. Induction arced through pads placed under the outrigger on the crane (Figure 9). It is important to note that wildfires are another risk from AC induction that need to be accounted for by line workers.
