# Arc Protection During High Voltage Live Work

**Abstract** – *The bare-hand technique is a common work method applied in high voltage power grids. Rules, guidelines, and recommendations must guarantee an appropriate level of protection against electric shock, electric field stress, open flames, and arc flash incident energy. Traditionally, conductive clothing has been used by line workers for protection against electric fields of extra-low frequency. Most conductive clothing designs offer high efficiency as Faraday-cages. Although screening efficiency of a well-designed clothing is high enough to significantly decrease electric fields for prevention against electric shock, other hazards should be addressed. Transmission line geometries may guarantee required clearances between conductive parts at different potentials. However, additional protection measures may be required. Several accidents occurred to line workers using hot sticks, insulating boom trucks, insulating scaffolds, and helicopters. During flashover, the incident energy of the arc may be high and exceed the threshold of a second-degree burn. This requires risk assessment and mitigation of arc flash and other thermal

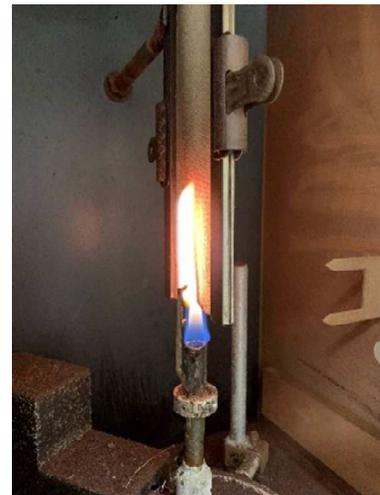
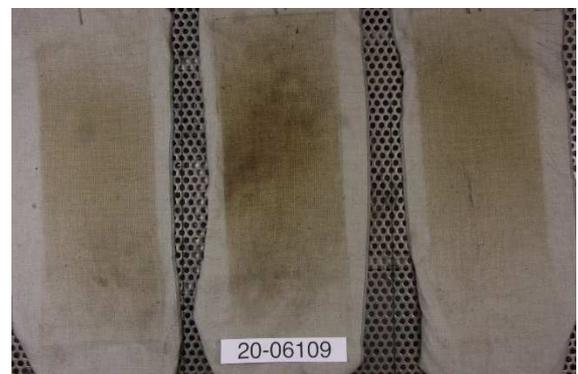
Fig. 1a, 1b – Examples of conductive fabric samples exposed to a vertical flame test

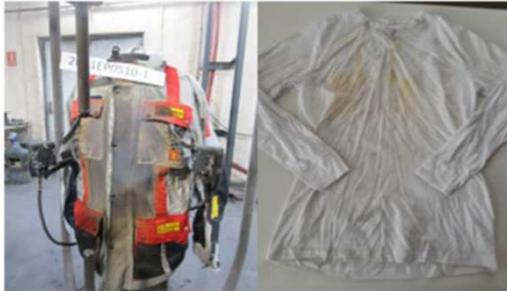
Fig. 2 – Example of a conductive garment arc test per ASTM F2621

CIGRÉ has recently started working group B2.87, which will provide guidelines and collect international regulations for PPE used for bare-hand work. Electric utilities can also arc test complete garments using the manikin test, ASTM F2621 (Figure 2). In this test, the garment can be evaluated for ignition, melting and dripping of garment components, and evaluation of clothing indicators. The target arc incident energy can be setup under 120% of the rated ATPV/EBT value of the garment label. Components of importance are fabric, zippers, snaps, visibility enhancements, trim, thread, and heraldry. Other standards, such as IEC 60895:2020, evaluate flame retardancy, but do not include arc performance. The flame retardancy test per IEC 60895:2020 is like ASTM D6413 in terms of assessing resistance to ignition [12], [13], [14]. Per OSHA/NESC, the arc flash boundary (AFB) defines the area around a live conductor where AR/FR clothing is required while conducting live work. Outside the AFB, AR/FR clothing is not required. AFB is defined as the area where the incident energy at the body of the worker is 2.0 cal/cm<sup>2</sup> or greater. Some electric utilities use a more stringent value, 1.2 cal/cm<sup>2</sup>, based on the Stoll curve, or onset of a second-degree (curable) burn. The US Department of Energy (DOE) adopted NFPA 70E which uses 1.2 cal/cm<sup>2</sup> for arc flash boundary and State-owned electric utilities shall abide by that value [15], [16].
